Republic of the Philippines
Department of Agriculture
AGRICULTURAL TRAINING INSTITUTE

RECOMMENDATION FOR REPAIR WORKS

March 15, 2022

Subject: **TELEPHONE CABLING RECONFIGURATION**

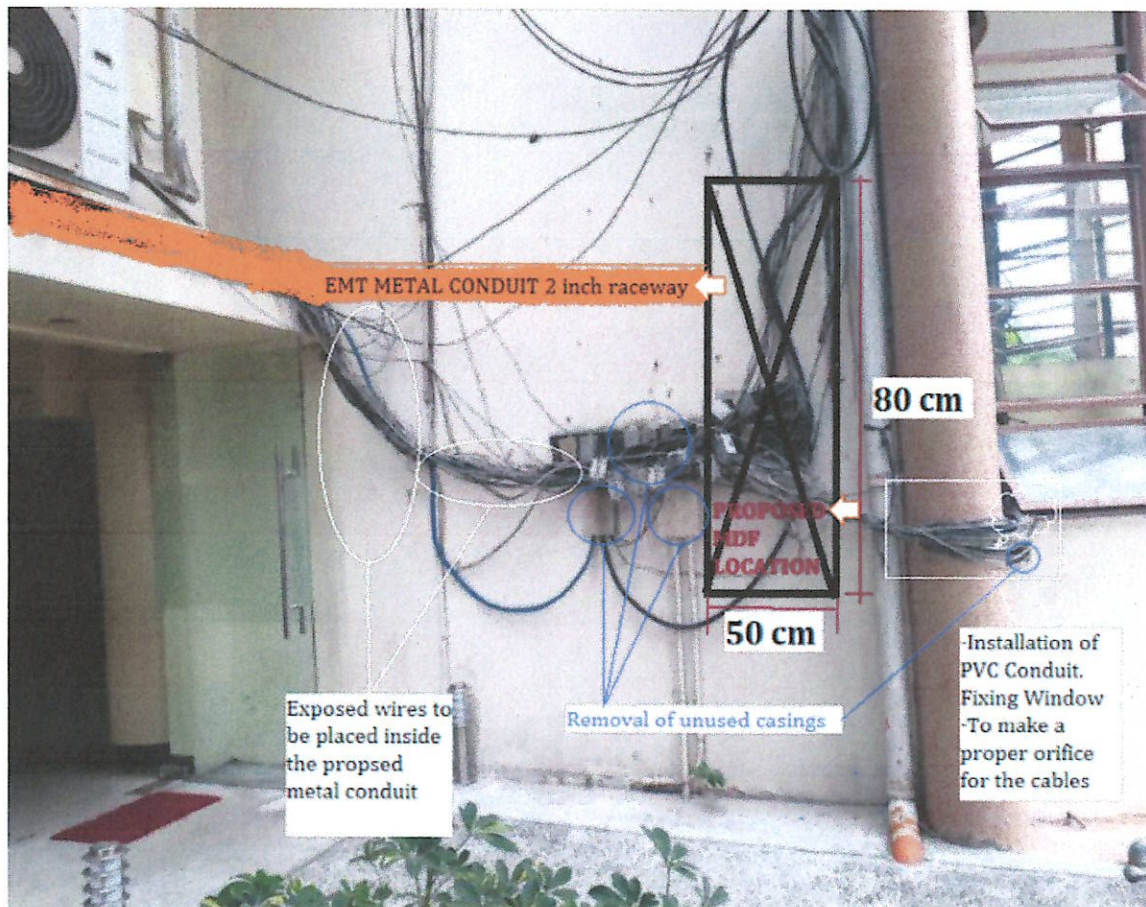
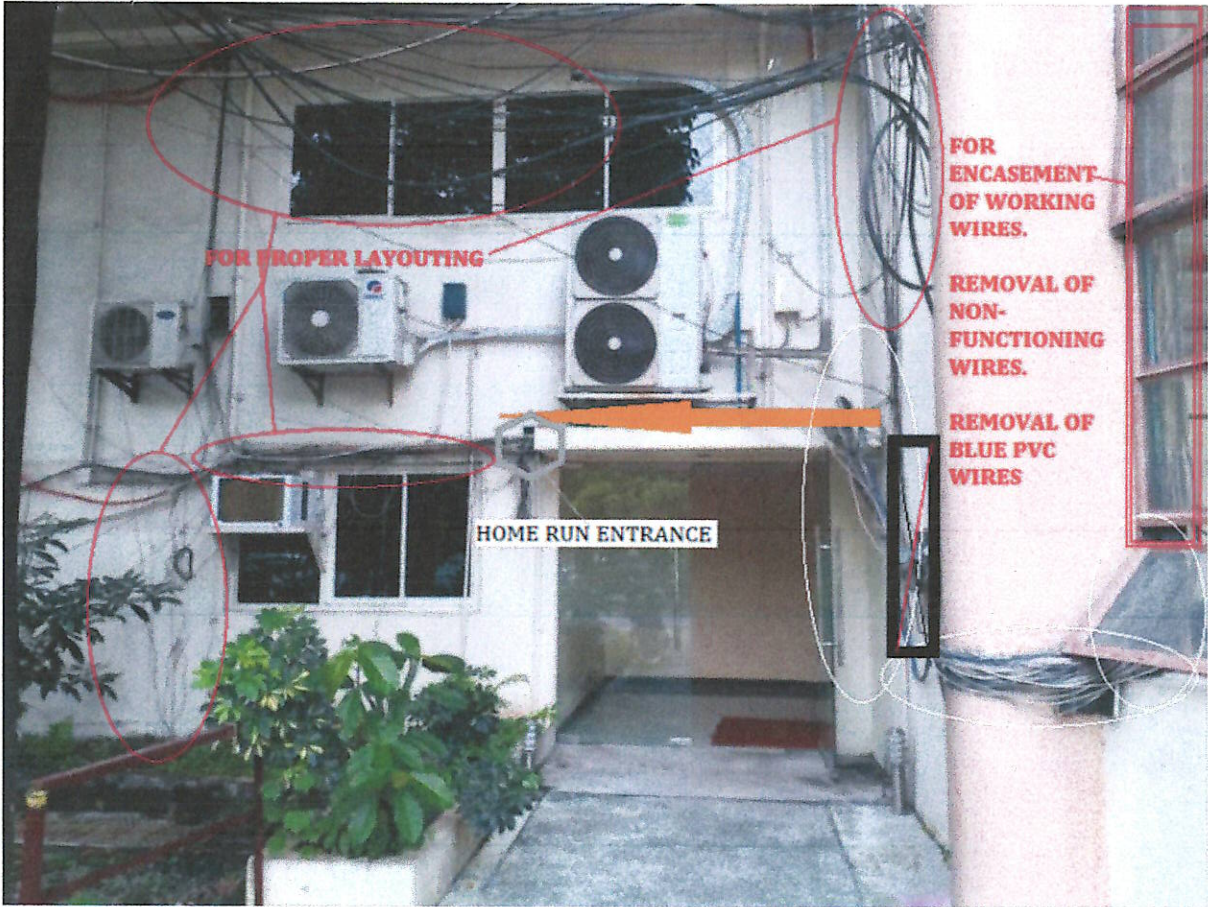
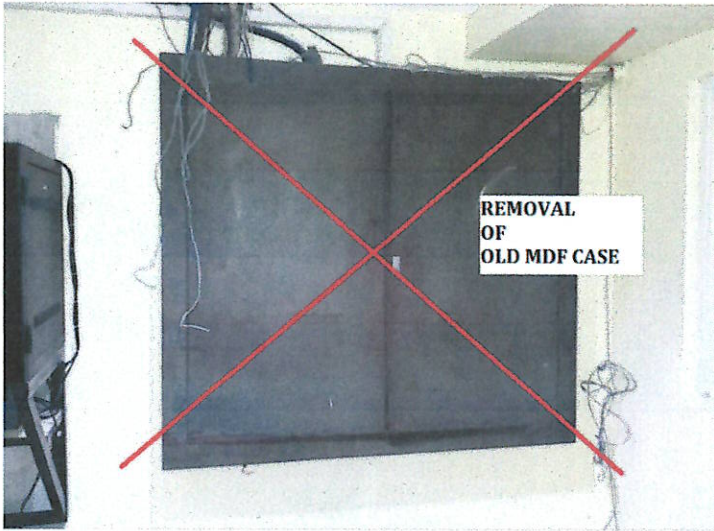
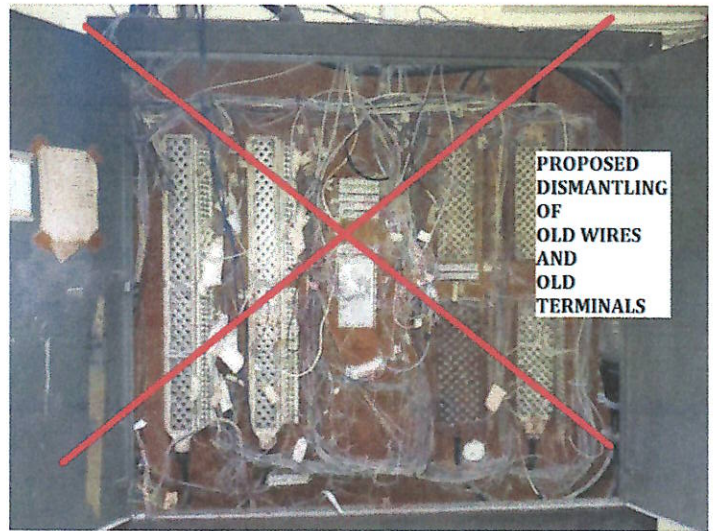
Noticeable untidy lay-outing of telephone and internet wirings outside ATI building, rear side, intertwined active and inactive lines of undetermined use if PLDT or local number lines, outdated Main Distribution Frame and Terminal blocks that cause frequent telephony problems.

It is highly recommended to take a service provider for technical assistance to perform the required scope of works below for telephone cable reconfiguration

1. Determine which wires are in use. Separate Directline, Fax and UTP cables. Separating PLDT and Local lines.
2. Tracing of dial tone, and any method of tracing communication wires without disruption.
3. Dismantling of the outdated panel board both outside and inside the building.
4. Proper installation of conduit and cabling.
5. Proper tagging of each line for convenient troubleshooting.
6. Disposal of collected debris from work locations.
7. Inventory of all Existing Locals
8. Inventory of all Existing Direct Line
9. Inventory of all Existing Fax Line
10. Tracing the location of locals and wirings
11. Tracing the location of Direct Line
12. Tracing the location of Fax Line

13. Cable Laying 200 run (2 pairs) especially drop wires, HDPE Jacket, sunlight resistant PVC jacketed. Encased in EMT conduit 2 inch diameter
14. Tagging of new jumper wire
15. Tagging of existing jumper wire from MDF
16. Dismantling of old terminals
17. Dismantling of old wires
18. Installation of new Main Distribution Frames for indoor and outdoor complying IP65, NEMA 4, EN60529 with the agreed dimensions of 50cm by 80 cm by 20 cm.
19. Installation of new terminal port
20. Installation of Access Ceiling Panel
21. Testing of all telephone unit twisted pair 0.65mm (22AWG)
22. Hauling of dismantled items *-to be submitted to SMO*
23. Documentation of technical works
24. Restoration works of affected areas
